DEFENDANT, HAMILTON BEACH PROCTOR-SILEX, INC.'S,
EXPERT DISCLOSURE

Report of John J. Datovech, P.E., C.F.E.I.
in the matter of
Vermont Mutual Insurance Company,
a/s/o Robert and Nancy McNeil and
Robert and Nancy McNeil
v.
Hamilton Beach / Proctor-Silex, Inc.

C.A. NO. 04CV12257NG
In the United States District Court
District of Massachusetts

April 17, 2006

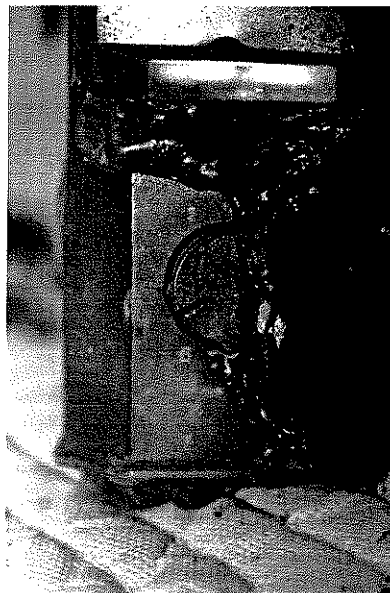
The subject toaster displays a pattern of high-temperature damage consistent with the product being in a fire. The thermoplastic housing is partially melted and burned. The lifter knob is fused into the re-solidified plastic housing in a down position, but it is not completely at the bottom of its travel. The color knob is partially melted and also is fused into the re-solidified plastic housing in a full-dark color setting (see Figure 1).

Figure 1: Color Control on Full Dark Setting (6 on a scale of 1 to 6)

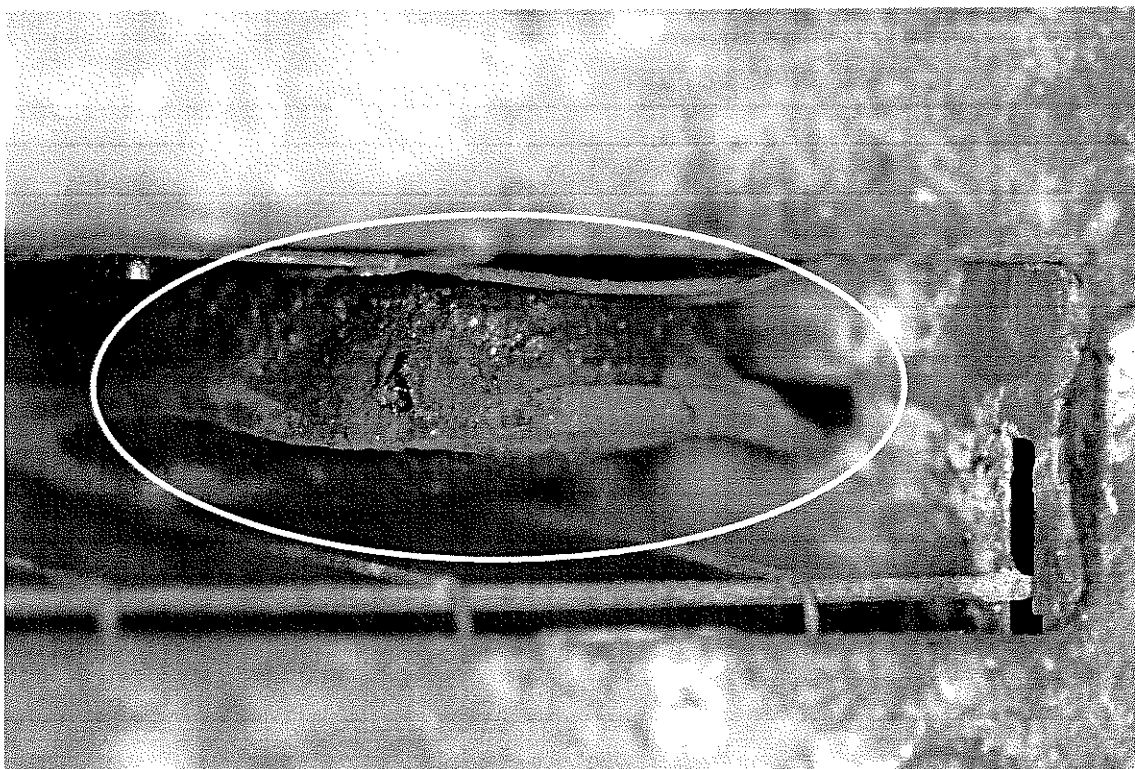
The subject toaster also shows signs of being in use prior to the fire. The remains of a charred, swollen toaster pastry are in the right bread well (see Figure 2).

Figure 2: Remains of swollen and charred toaster pastry in right bread well

3. The toaster was being misused prior to the fire.
 - a. The toaster was being used to cook a toaster pastry on the darkest toast color setting.
 - b. The toaster was in use while unattended.
 - c. Both of the above actions directly contradict the instructions provided in the hazard communications supplied with the toaster in both the Use & Care Guide and the separate Drop-In Warning Sheet.

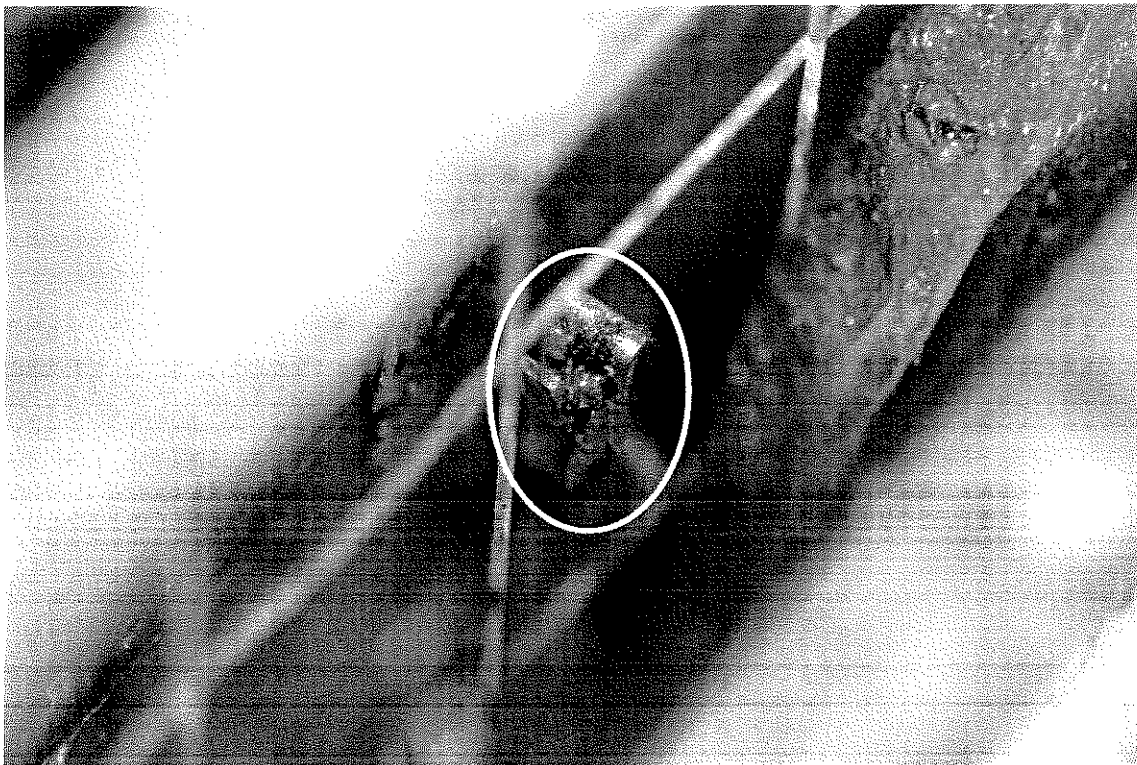
The swollen toaster pastry filled the gap between the grill wires (bread guides). The bimetal of the toaster is warped toward the rear of the toaster, and there is also charred debris on the bimetal of the toaster (see Figure 3).

Figure 3: Bimetal of toaster covered with charred debris

- d. The physical evidence indicates the toaster's release system was functioning properly at the time of the fire.**
 - i. The bimetal is warped toward the rear of the toaster. This means the bimetal was moving properly under the influence of heat.**

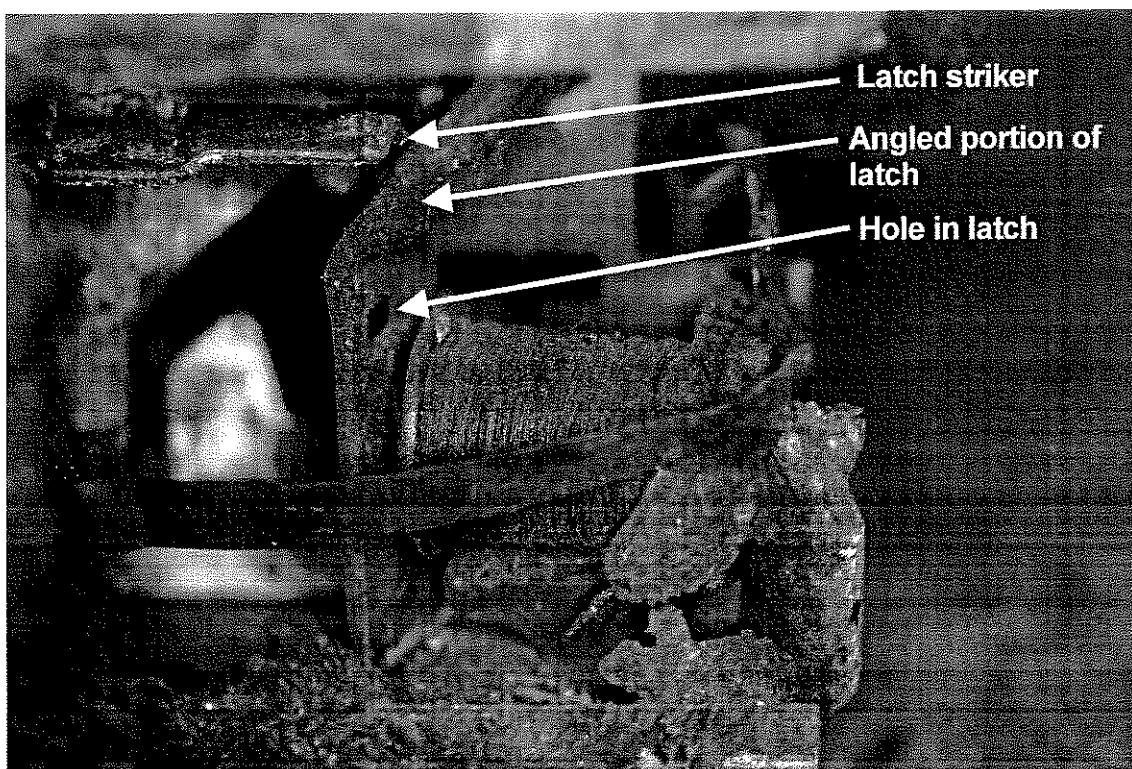
The slide of the toaster is resting towards the bottom of its intended travel, but not all the way at the bottom, latched position. The lifter spring is permanently stretched at the top. The latch striker is resting above the angled top of the latch bar. The latch striker is not engaging the slot in the latch (see Figure 4). The moving contact blades of the line switch are not in contact with the fixed-position contact terminals. X-rays of the toaster indicate no signs of abnormal electrical activity.

Figure 4: Latch striker resting above the hole in the latch

- ii. After the fire, the toaster is not in the completely down and latched position. This shows that the latch release and the toaster carriage moved upward. This shows the solenoid was energized, which means the thermal control switch closed. Accordingly, the pusher rod moved to close the switch, which provides further evidence that the bimetal moved under the influence of heat.**
